## State of Utah DEPARTMENT OF NATURAL RESOURCES DIVISION OF OIL, GAS AND MINING

RE:

Site Inspection, Cactus Rat Mine, Atlas Minerals,

M/019/009, Grand County, Utah

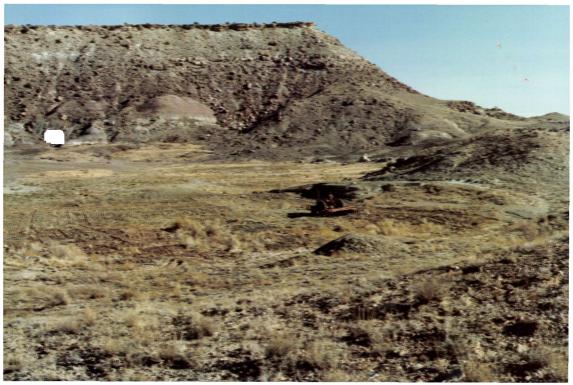
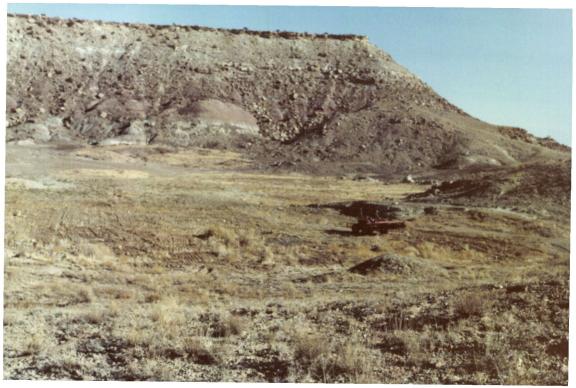
m/019/009

Preclamation Dischus in Progress

During my inspection of the site, the contractor, B & W Construction was in the process of discing the 14 - 15 acres that was going to be replanted at this site. The acreage will be disced, then broadcast seeded and then springtooth harrowed to scarify the seeds. After the reseeding efforts have taken place, the operator will fix three sites that are subsiding. Today's inspection was to verify that reseeding was taking place and also to discuss any other reclamation concerns remaining at the site. Either the operator will verify, by taking pictures or Mr. Venticinque will verify for me, by doing a later inspection, that the subsidence problem has been mitigated at this site.
